OFFICE OF THE AUDITOR GENERAL

PERFORMANCE AUDIT REPORT

CONSTRUCTION, REHABILITATION AND MAINTENANCE
OF DRAINAGE SYSTEMS IN URBAN AND
PERI URBAN AREAS 2020-2023

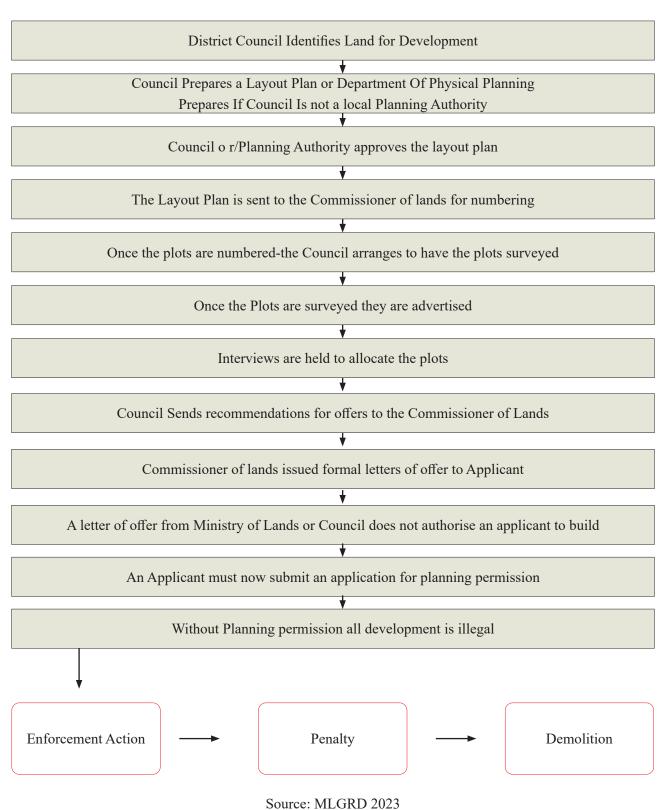
Figure 4.1: Plot Allocation Process

Local Authorities develop detailed and zoned Local Area Plans (LAPs) which are based on IDPs, encompassing Green Fields (New land) and Brown Fields (already developed land). For Green Fields, the Local Authorities identify and plan plots with utility services and amenities, seeking approval from the Commissioner of Lands. Once approved, the Engineering Department oversees the implementation of these plans, including the construction of drainage infrastructure. Figure 4.1 shows a flowchart of land allocation for Green Fields.

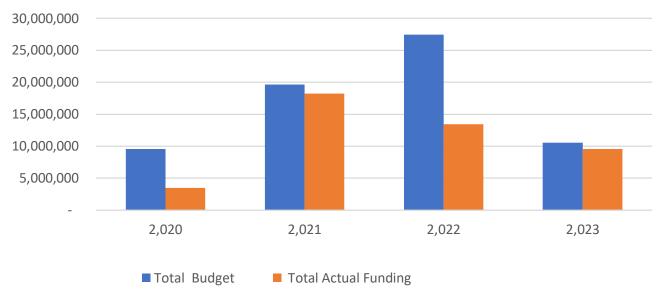
Figure 6.3 Total budget Vs Actual Funding for Drainage Construction

An examination of the budget allocation for the period 2020 to 2023 revealed a cumulative decline. While there was a notable increase from 2020 to 2021, with a budget boost of K12,492,952 from K6,176,092 to K18,669,049 subsequent years witnessed a consistent reduction, plummeting from K18,669,049 to K5,426,870, indicating a decline of 71 % percent. See Figure 6.3

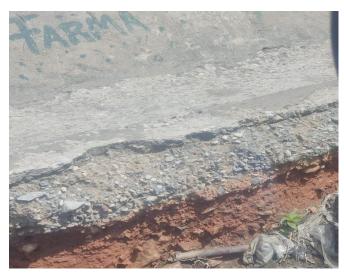
Figure 6.4: Eroded road in Sesheke

Eroded road in Lusaka

Further, there was a risk of flooding which resulted in damage of properties and disease outbreaks.

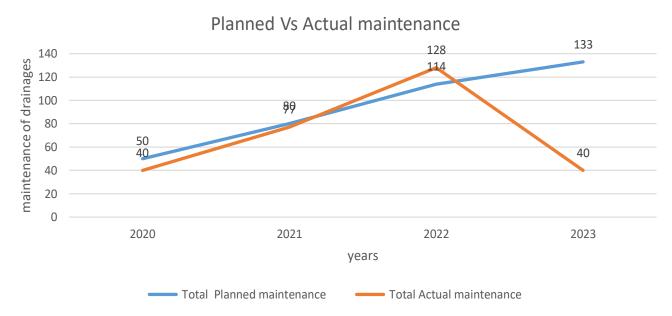
Figure 6.5: Planned Against Actual Maintenance Activities Implemented

The audit through responses from thirty-eight (38) Local Authorities revealed that not all of them had formulated plans for maintenance activities while the status of the remaining seventy-eight (78) Local Authorities was unknown as responses to the request for information had not been provided as of April 2024. The audit also revealed that not all Local Authorities planned for maintenance activities, with varying implementation rates during the period from 2020 to 2023 as detailed in **Appendix 6.** Despite the plans, Local Authorities fell short of full implementation in 2020, 2021 and 2023, with 2022 being an exception where all planned activities were successfully executed. See figure 6.5 below.

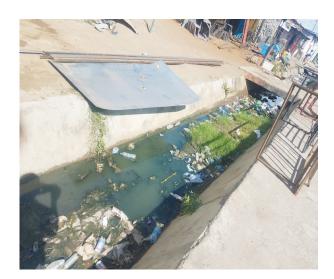
Figure 6.6: Clogged, Uncleaned Drainage with Grown Grass in Chawama and along Mumbwa road in Lusaka.

The audit, through physical inspections revealed that drainages were not adequately maintained. In October 2023 it was observed that numerous drainages were obstructed by litter, garbage and silt. Of the forty-three (43) drainages inspected, only eleven (11) were found clean, constituting 26%, refer to **Appendix 7** showing the status of drainages. Instances of severe silt accumulation were identified in locations like the main roads in Kaoma CBD in western Province and a drainage in Balastone area in Lusaka with a depth of two (2) meters entirely covered in silt due to non-maintenance. Additionally, there were various areas including Lusaka and Eastern provinces which include Lusaka CBD, Emmasdale, Chunga, Garden, Kanyama, Chawama, George, Matero and the Light Industrial area where drainages were blocked by solid waste. Figure 6.6 shows an example of drainages clogged with solid waste in Chawama compound in Lusaka.

The audit, through responses to circularized questionnaires and interviews with Local Authorities, revealed a deficiency in resource allocation for maintenance activities, leading to infrequent drainage cleaning. Further investigation, including site inspections, discussions with performance contractors responsible for areas such as Kafue-Lumumba junction, Lumumba drain, Kalabo Road, Villa area, Emmasdale Chifundo road, Esther Lungu Road, Kafue Round About, Lilayi Road Water Works area and Kamwala South to Kamulanga Roads, showed delays in payments by the MLGRD. Performance Contractors cited inconsistent drainage maintenance due to payment delays, coupled with a shortage of manpower and inadequate protective gear. Workers from various Performance Contractors faced challenges, including delayed payment of salaries averaging three (3) to four (4) months and the lack of relevant tools and equipment such as dredgers, forklifts, and protective clothing. Notably, the underground drainage in Kabwe remained clogged due to the absence of a dredger and appropriate protective gear for underground work. The MLGRD engaged performance contractors for Lusaka drainage cleaning due to its insufficient capacity in terms of manpower and equipment. Challenges were also noted in areas such as Lilanda and Chunga where performance contractors struggled with inadequate manpower due to workers ceasing operations amid issues pertaining salary payments.

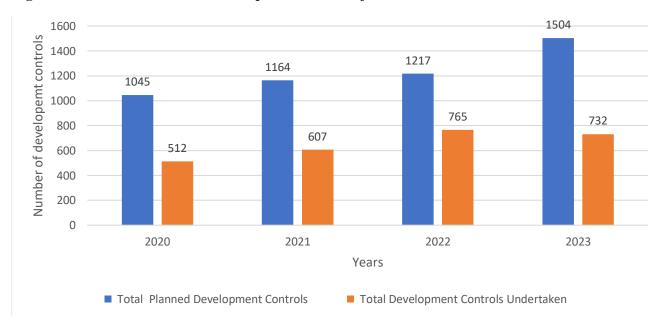
Figure 6.7 Planned Vs Actual Development Controls for Period 2020 to 2023

Through data analysis it was established that out of 116 Local Authorities, only thirty-eight (38) planned to undertake 1045 development controls in 2020, 1164 in 2021, 1217 in 2022, and 1,504 in 2023 while the status regarding the planned and actual development controls undertaken was not provided by seventy-eight (78) Local Authorities as of April 2024. However, not all planned developmental activities were implemented during the review period, as illustrated in Figure 6.7.

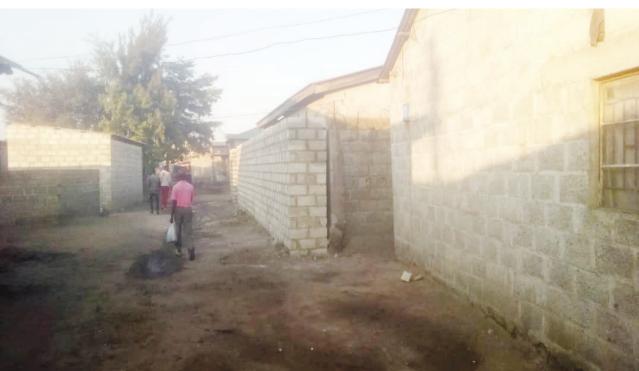
Figure: 6.8: Encroachments on Drainage Reserve in Chunga

In this regard, a case reported by WDCs on road encroachment in Chunga area, Lusaka, which was not addressed by the Lusaka City Council, resulting in the construction of a structure within the road reserve. Pictorial evidence of the reported construction is shown below:

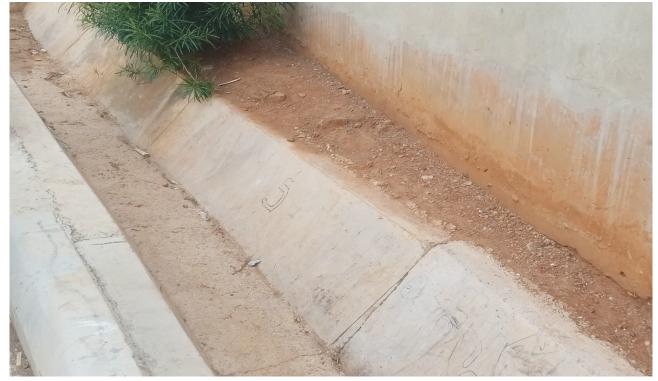
Figure 6.9 Structure built on road reserve in Chongwe.

Physical inspections of drainages uncovered instances of structures erected on top of drainage systems and within road reserves, limiting space for drainage structures and other essential services. An illustrative example occurred in Chongwe, where constructions encroached upon the reserved area designated for services like drainages, as depicted in Figure 6.9

Local Authorities cited low staffing levels, particularly in the number of Building Inspectors, as a primary reason for not effectively conducting development controls. Most Local Authorities reported an average of only two Building Inspectors covering entire districts, with exceptions like Lusaka City Council, which had recruited 15 inspectors and planned to station them in various zonal centers within the district. Inadequate transport was another common challenge, as there were no dedicated vehicles for development control exercises, hindering inspections based on the availability of transportation. This issue significantly impacted larger cities like Lusaka, Ndola, Chipata, Livingstone, and Kitwe. In contrast, Chingola Municipal Council demonstrated progress in enforcing orders, as evidenced by enforcement notices issued to offenders between November 2020 and March 2023, along with documented demolition reports.

The failure to effectively conduct development controls poses several risks, including encroachment on areas designated for drainage structures, limiting future development services due to reduced buffer zones. Additionally, there is a risk of unplanned settlements, interference with planned development programs, construction on drainage structures, persistent illegality in construction, and the indiscriminate disposal of solid waste in drainages.

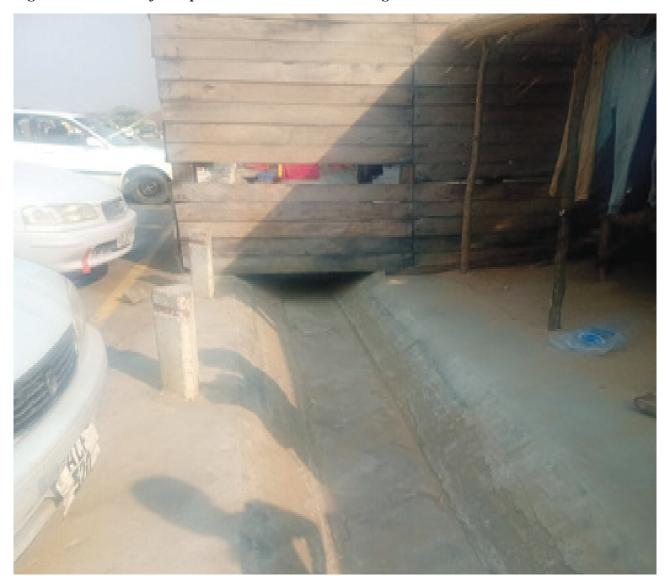
Figure 6.10 Makeshift Shops Constructed on the drainage line in Sioma.

This scenario was substantiated by onsite inspections conducted in Sioma District as depicted in Figure 6.10 below.

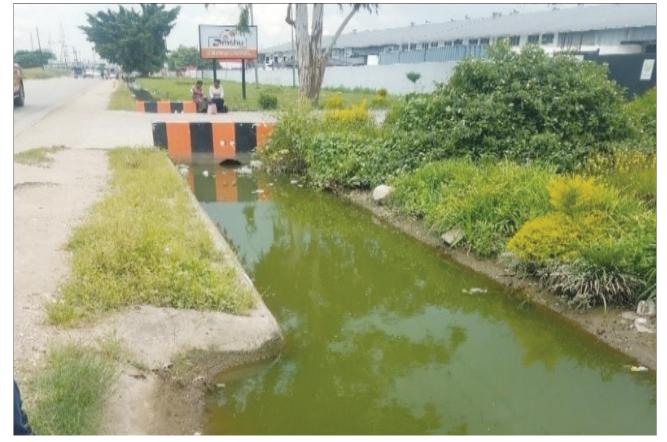
Figure 6.11: Stagnant Water off Mumbwa road in Light Industrial Area

The failure to regularly maintain drainage systems by removing litter, garbage and effluents poses risks such as flooding and water stagnation. These conditions can contribute to the breading of pests like flies and mosquitoes, leading to the spread of infectious diseases. Figure 6.11 below illustrates an example of drainages with stagnant water along Mumbwa road in the light industrial area in Lusaka.

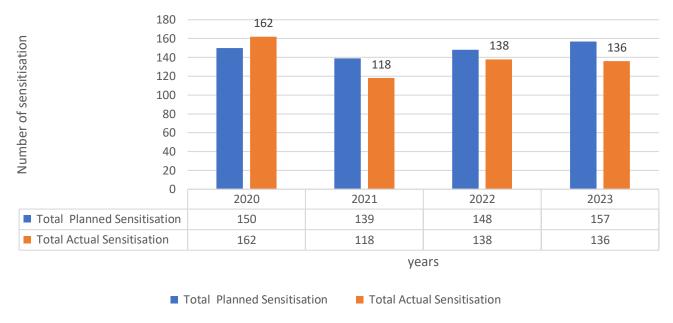
Figure 6.14: Planned Against Actual Sensitisation Activities implemented.

The audit through analysis of data circularisation for planned and actual implementation of sensitisation activities showed that from the thirty-eight (38) Local Authorities that had responded to the request for information, twenty-two (22) had planned to undertake sensitisation activities in 2020, twenty-three (23) in 2021, twenty-four (24) in 2022 and twenty-five (25) in 2023. A further analysis showed that there was a total of 162 in 2020, 118 in 2021, 138 in 2022 and 136 in 2023 sensitisation activities undertaken. See Figure 6.14 below for details.

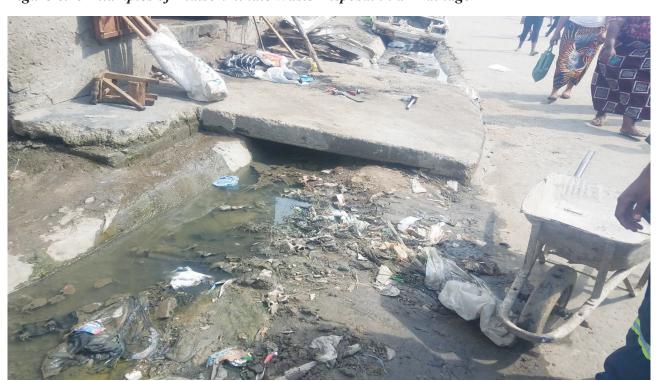
Figure 6.15 Examples of Indiscriminate Waste Disposal in a Drainage

The consequence of low sensitisation levels was evident through increased indiscriminate waste disposal in drainages by communities, leading to blockages, vandalism, and improper waste disposal. This was particularly observed in peri-urban areas such as Kanyama, Chawama, George compounds, and the CBD in Lusaka. Figure 6.15 illustrates an example of indiscriminate waste disposal in a drainage in Chawama.
