REPUBLIC OF ZAMBIA  
OFFICE OF THE AUDITOR GENERAL

# **Performance Audit on Government Efforts to Ensure Availability of Water Harvesting Infrastructure to Mitigate Water Scarcity in Zambia 2021-2024**

DECEMBER 2024

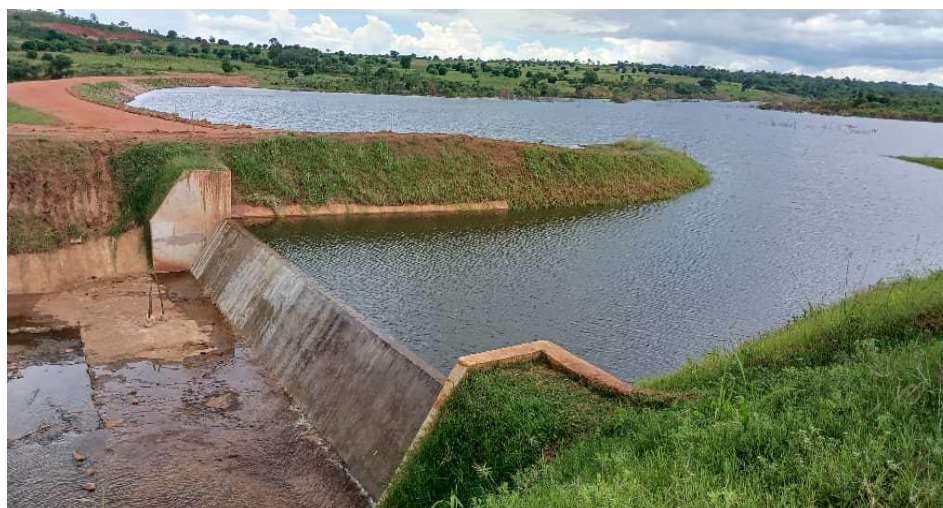
**Figure 6.3: Newly constructed Kapekesa Dam in Chasefu District**

As can be seen in the table above, there was an increase in the planned number of constructions from one (1) in 2021, to three (3) in 2022, sixteen (16) in 2023 and twenty-eight (28) in 2024 while constructions remained stagnant at one (1) during the period under review. A site inspection of Kapekesa Dam planned for construction in 2021 and constructed between 2022 and 2023, revealed that the contractor had completed works and was issued with Project Completion Certificate on the 27<sup>th</sup> December 2023. Although the contractor handed over the Dam to MWDS, the dam had not been commissioned and handed over to the community as of September 2024, nine (9) months after completion. Figure 6.3 below shows the newly constructed Kapekesa Dam.

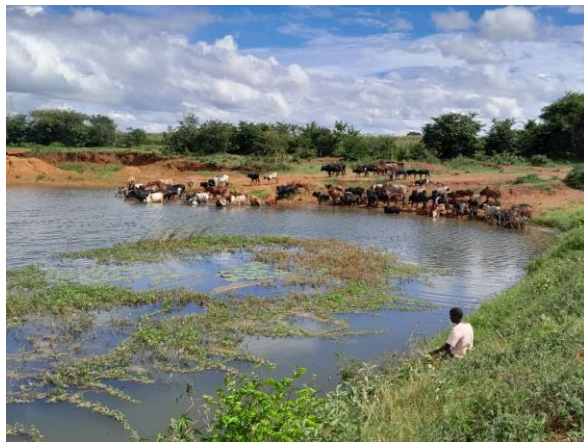
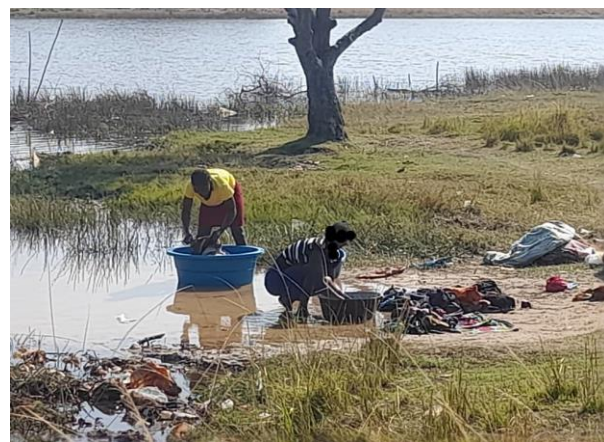
**Figure 6.4: (a) Animals drinking from Mwase Dam (b) community members washing in dam area at Lui Dam**

For example, due to non-designation of areas for animal watering, animals drunk from the dams as observed at Mwase dam in Lundazi (see Figure 6.4 (a) below). Additionally, community members were observed washing in Lui and Shimboela dams (see Figure 6.4 (b) below). Further, it was observed that there was no provision for water abstraction at Lui dam as shown in Figure 6.5 below.

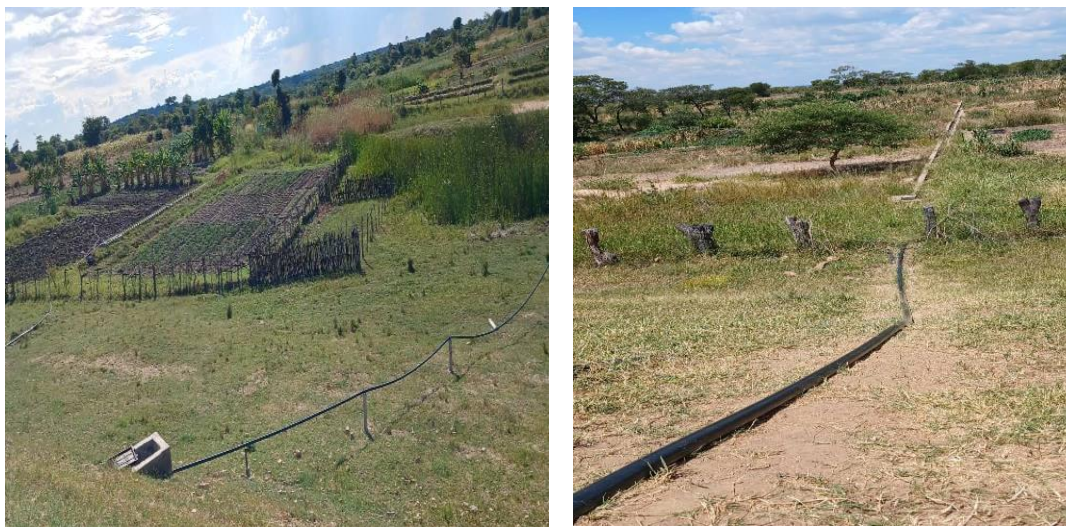
**Figure 6.6: (a) Irrigation system at Nabuyani dam (b) Canal at Siandwazi Dam**

On the contrary, the audit observed that there was collaboration in selected districts<sup>89</sup> at planning stage. In this regard, physical inspections and interviews confirmed that the dams were designed with canals for irrigation and domestic purposes. Figure 6.6 (a and b) below shows an irrigation system and canal at Nabuyani and Siandwazi Dams.

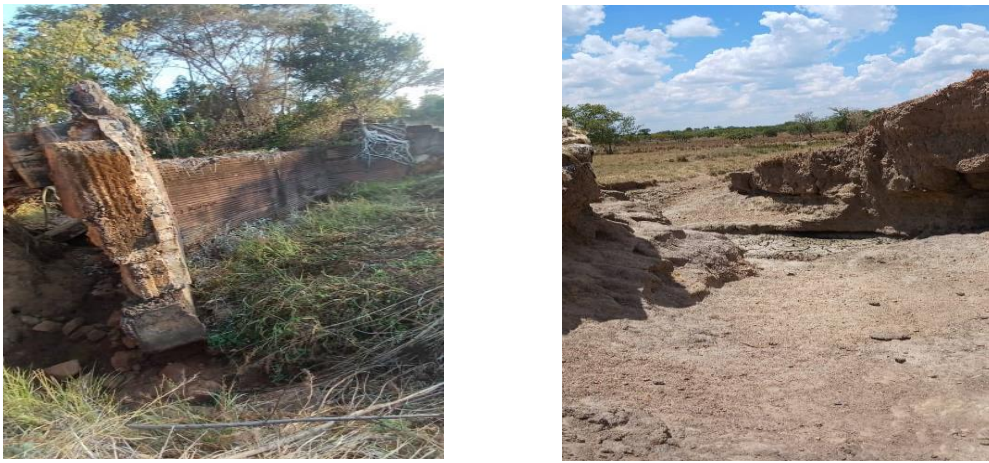
**Figure 6.7: (a) Kabukafu Dam in Kasempa District (b) Muzya Dam in Zimba District**

The low rate of dam rehabilitation poses the risk of high cost of rehabilitation and dam failure which may result in reduced number of operational dams to harvest water. Further, dam failure may also result in flooding which poses a risk of destruction to both life and property. Figure 6.7 below shows examples of dam failure at Kabukafu and Muzya dams.

28	Nachibanga Dam	Pemba	Dam under rehabilitation
29	Ndondi Dam	Pemba	Dam under rehabilitation
30	Nabowa	Kaoma	Dam under rehabilitation
31	Changula Dam	Shibuyunji	New Dam under construction
32	Chibwe Ntholo Dam	Pemba	New Dam under construction
33	Kafulafuta Dam	Masaiti	New Dam under construction
34	Kabukafu dam	Kasempa	Dam not functional - Breached

<b>No.</b>	<b>Name of Dam</b>	<b>District</b>	<b>Maintenance equipment provided</b>
35	Mahilo Dam	Kaoma	Dam not functional - Breached
36	Muzya Dam	Zimba	Dam not functional - Breached
37	Siambelele dam	Zimba	Dam not functional - Breached

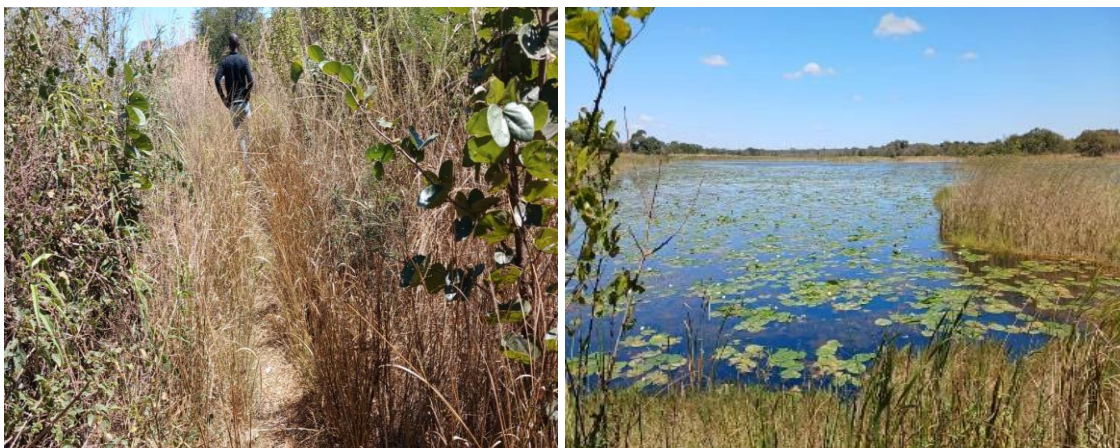
**Figure 6.9: (a) Overgrown vegetation on embankment (b) Overgrown weeds**

For example, as depicted in Figure 6.9 below, there was overgrown vegetation, trees on embankments and weeds in and around Kantolo Weir.

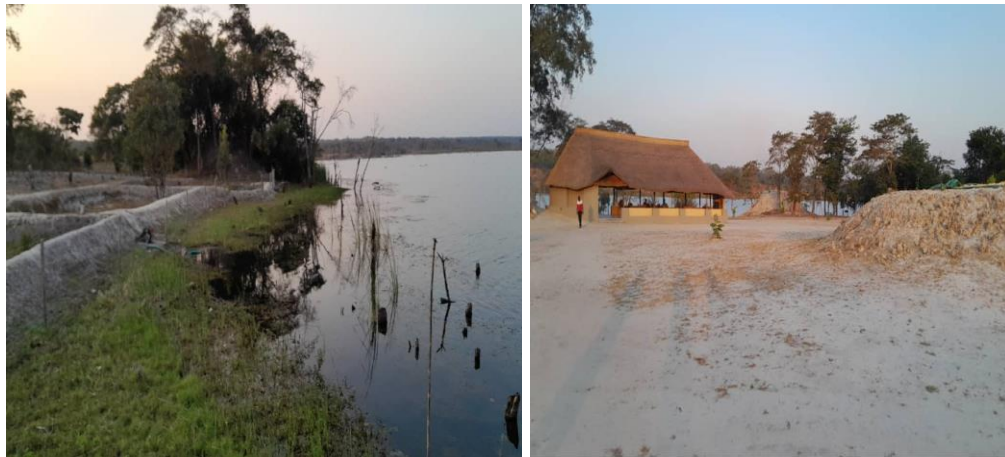
**Figure 6.10: (a): Fishponds and a shelter at Katembula Dam**

The audit through physical inspections revealed that some members of the community had encroached and constructed private properties around some dams. For instance, the audit observed several constructions such as dwelling houses at Mahilo Dam in Kaoma, a fish pond and resort at Katembula Dam in Lufwanyama and constructions at Mitukutuku Dam in Solwezi. Figure 6.10

shows fishponds constructed on the banks of the Katembula Dam and Figure 6.11 shows constructions at Mitukutuku Dam below.

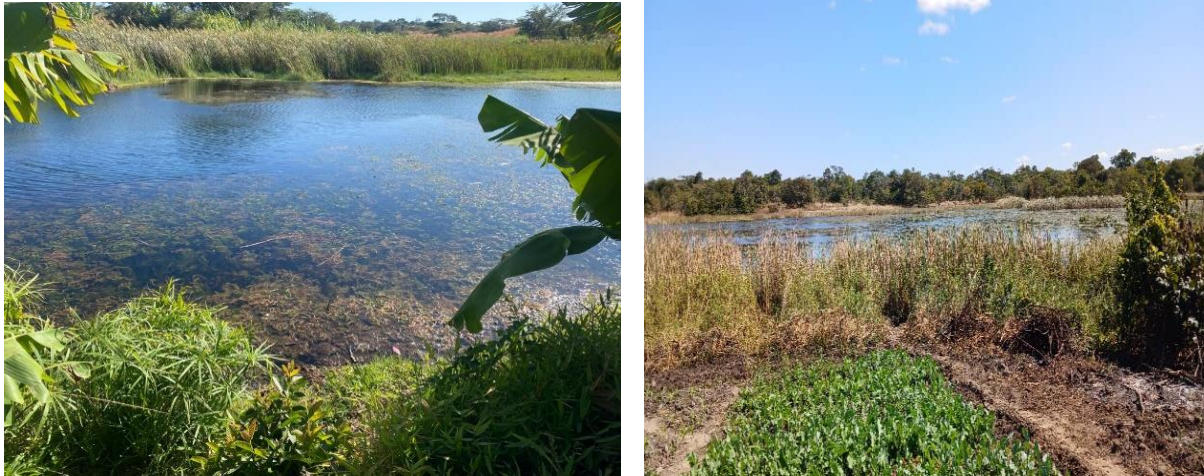
**Figure 6.12: a) Overgrown vegetation at Chilimulilo Dam b) Gardening activities within 50m at Kantolo Weir**

Community members were seen washing laundry on the banks of the dams while gardening activities were observed upstream and taking place within the fifty 50m buffer zone contrary to best practices. Figure 6.12 below shows overgrown vegetation at Chilimulilo Dam (a) and gardening activities within 50m buffer zone at Kantolo Wier (b).

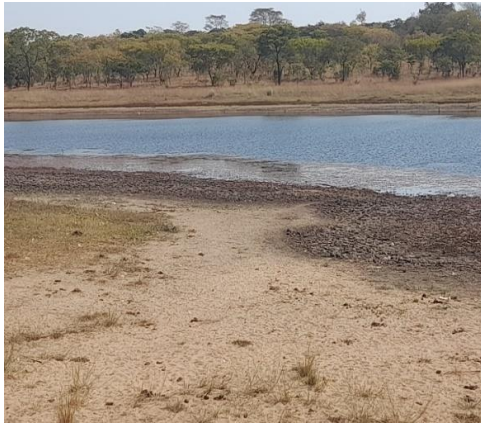
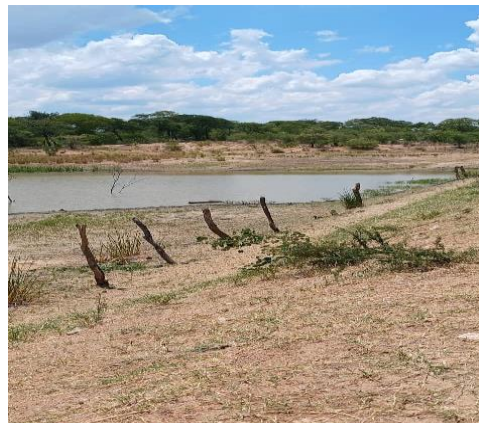
**Figure 6.13: (a) Reduced water levels in Shimboela Dam in Kaoma District b) Siandwazi Dam in Zimba District**

Additionally, among others, indiscriminate cutting of trees contributed to reduced levels of water in the dams. For example, at Siandwazi Dam in Zimba District, gardening activities were halted due to reported reduced water levels. Figures 6.14 (a) and (b) below show reduced levels of water in Shimboela and Siandwazi Dams. Similarly, Figure 6.16 below shows a dried Shimano Dam in Nkeyema District.
