# Report of the Auditor General on the

## Management of Environmental Degradation Caused by Mining Activities in Zambia.

July 2014

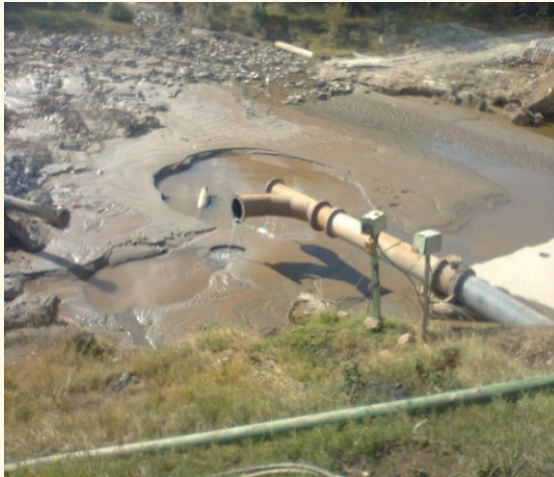
There were four(4) mines namely Non Ferrous Copper Mine, Mopani Copper Mine-Mufulira, Konkola Copper Mine Nchanga and Konkola IBU that continued after the privatisation of the mines to release water to the environment which was up to 48,069mg/l or 480% higher than the ZEMA authorised limit of 100mg/l. (**Appendix 11**)

*Sediments released in Nchanga and eventually Mushishima stream at Pollution Control Dam (PCD) by KCM Nchanga Division*

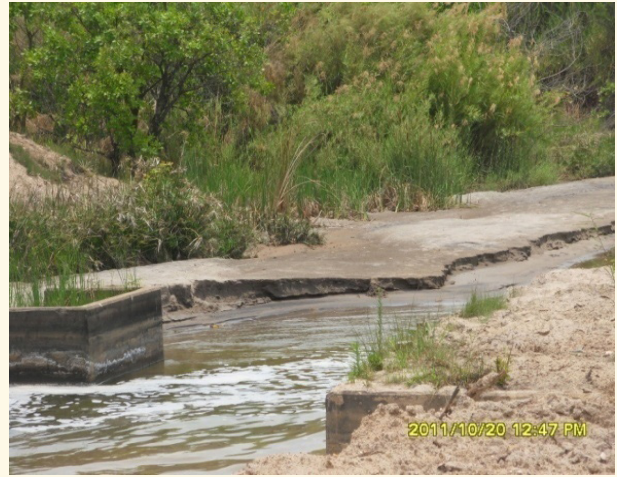
*Sediments from Muntimpa TSF reporting into Muntimpa stream*

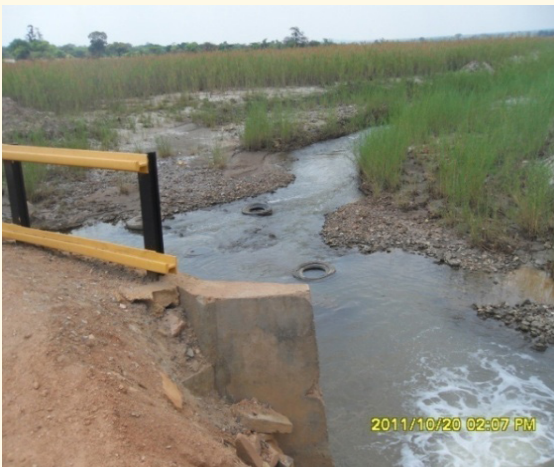
*Solids reporting into Mushishima stream*

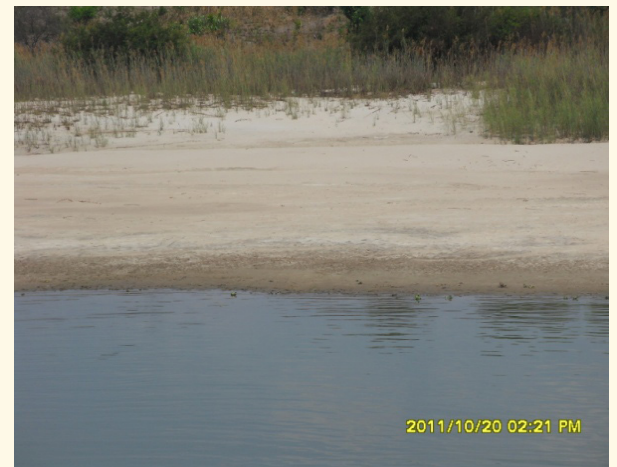
*Sediments on the embankments of the stream formerly known as Hippo pool*

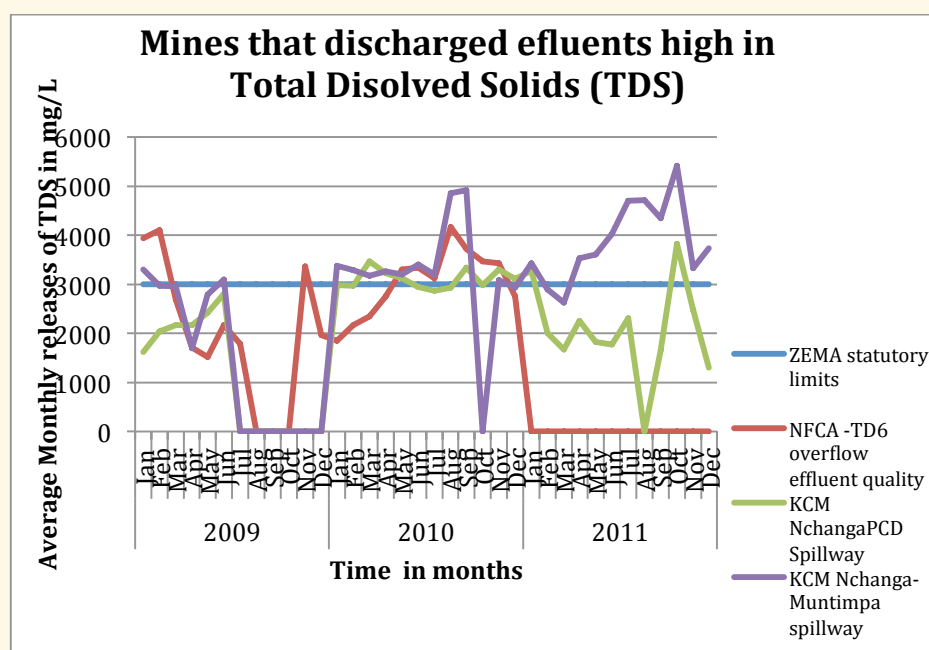
Chart 1.

It was also observed that there were no test results for water released to the environment for the period from August to October 2009 and January 2011 to December 2011 for Non Ferrous Copper Africa Mining Plc (NFCA) while KCM had no test results for the period July 2009 to December 2009 contrary to the licences conditions issued by ZEMA that required that average monthly test results be sent to ZEMA in a bi-annual report.

\* Other Mines not appearing were all below the statutory limits

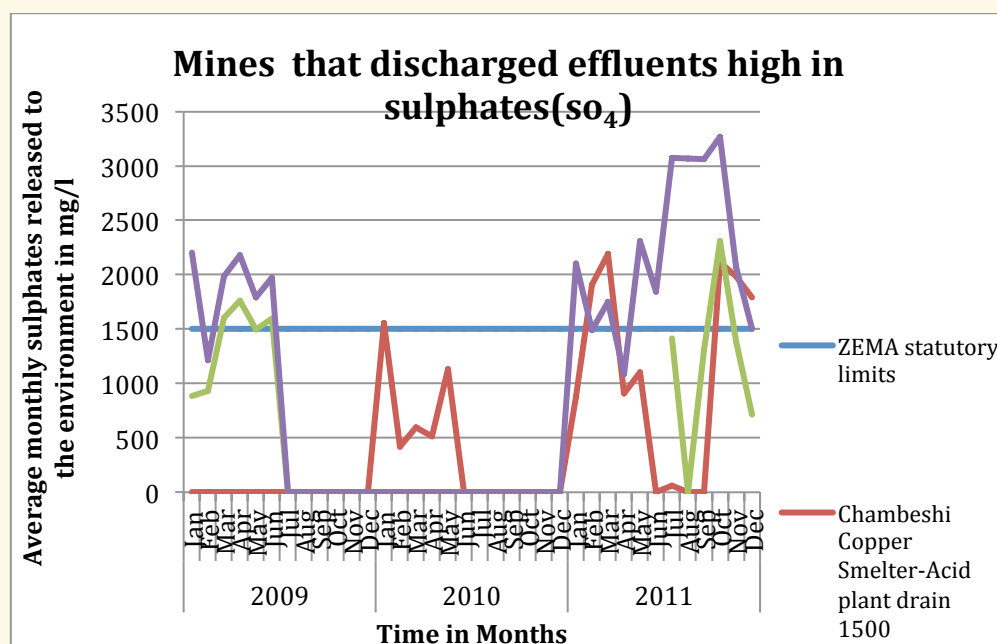
Chart 2.

It was also observed that Chambishi Copper Mine discharged effluents with high sulphates in 2011 of up to 2,189mg/l while there were no test results for the months of June to November 2010 and June, August and September 2011 (**Chart 2**)

\* Other Mines not appearing were all below the statutory limits.

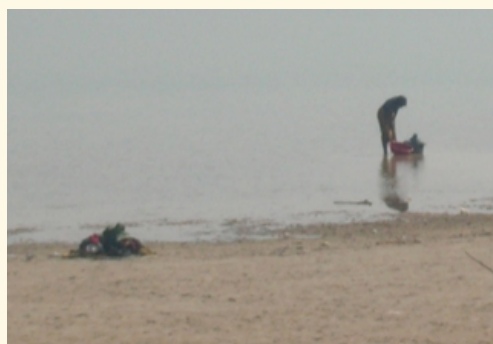
Out of a total of nineteen (19) tailings facilities inspected, ten (10) facilities namely Musi, Lubengele, Muntimpa, Chibuluma South, Chibuluma TD 1, Chibuluma TD 2, NFCA TD 6, Luano, Musakashi and Chambishi Metals tailings storage facilities had unrestricted access. In some instances, illegal miners were seen on site while in other instances, community members were seen bathing, playing and fishing in the dump/dam sites. **(See pictures below)**

*Woman seen washing clothes in the Lubengele Tailings Dam- KCM Konkola*

In line with licensing conditions, there should be no residential areas within 500metres of tailings, slag and overburden dumps. In addition, the practice of communities cultivating vegetables on toe dumps should be halted forthwith.

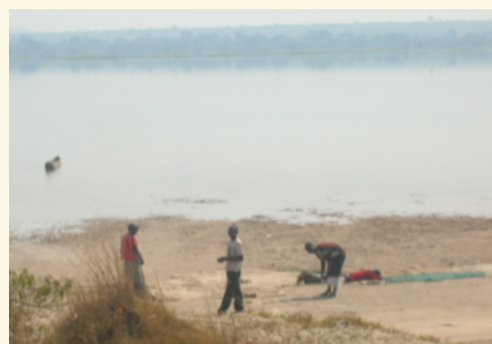
*Teenagers playing on the Lubengele Tailings Dam- KCM Konkola*

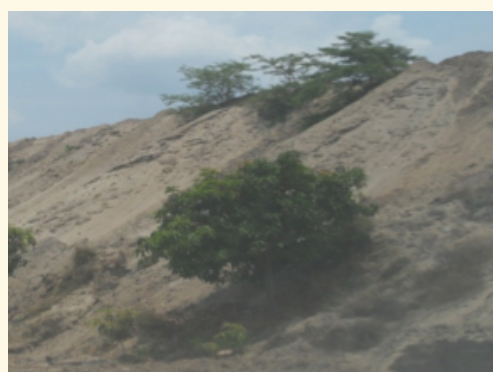
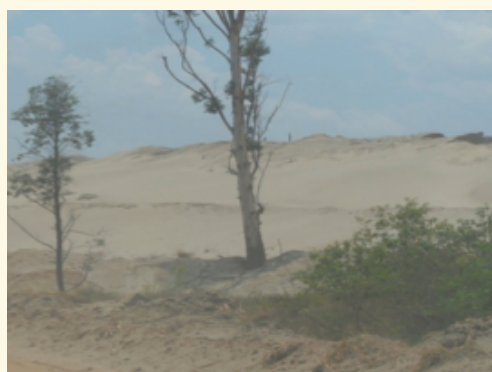
It was also observed that while all the mines had started carrying out progressive re-vegetation of the TSF, fourteen (14) facilities had sparsely vegetated and bare sections of the embankments and top beaches. As a result of the sparsely vegetated and bare sections of the embankments and top beaches, there was evidence of erosion gullies and wind-blown dust from the bare tailings surfaces.

*Sparsely vegetated embankments of Mutimpa Tailings Facility- KCM Nchanga exposing loose particles that can easily be blown by wind.*

Progressive rehabilitation, including vegetation management should be carried out regularly, in line with licensing conditions and other guidelines.

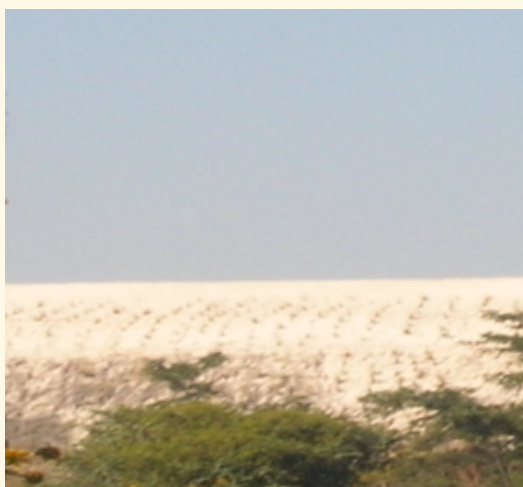
*Sparsely vegetated embankments of Chibuluma South Tailings Storage Facility exposing loose particles that can easily be blown by wind or eroded by rain water into the environment.*

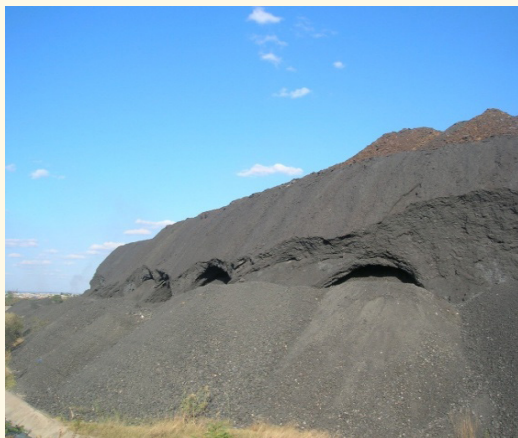
MCM slag dump No.1, L.C.M – old and new slag dumps, KCM unlicensed slag dump and dump No 67, Nkana slag dump-Chambishi Metals Mine had unrestricted access.

*Dug-out holes created by illegal miners on Nkana slag dump owned by Chambishi Metals mine*

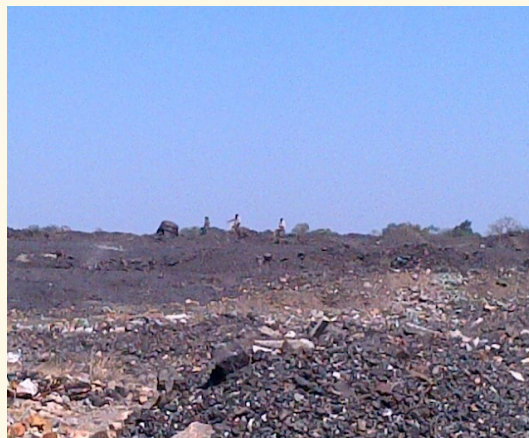
*Illegal miners on old slag dump at LCM*

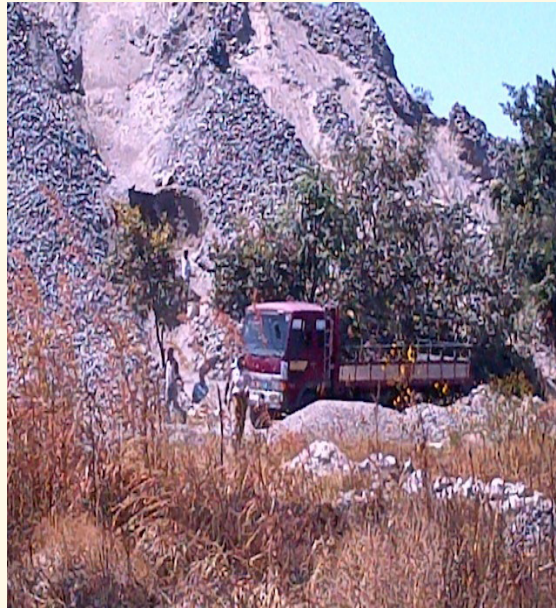
Out of a total of eighteen (18) dumps inspected, thirteen (13) facilities namely; South and Southwest waste rock dumps No. 18 and 14 respectively - L.C.M, Waste rock dump No. 5, 17, 18 and 20 and OB 1 and 2 - NFCA, OB 1, 2, 22, 23- KCM Nchanga, Chibuluma Mine OB had unrestricted access. Illegal miners were also seen on site.

*Illegal miners seen ferrying waste rock – LCM*

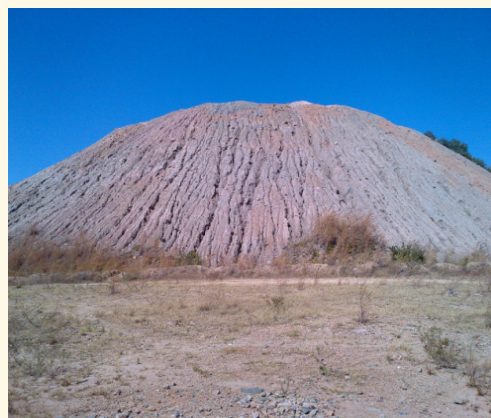
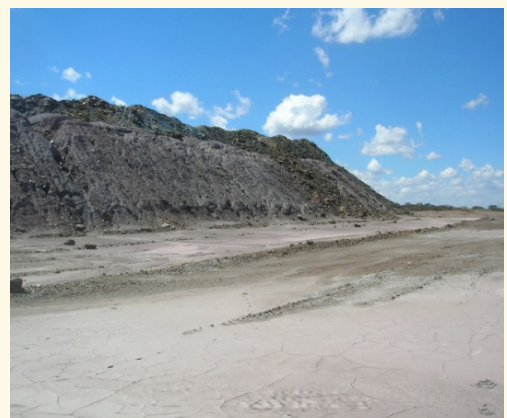
While most mines had started carrying out progressive re-vegetation of waste rock and overburden dumps, fourteen (14) facilities had sparsely vegetated and bare sections of slopes. As a result of the sparsely vegetated and bare sections of the slopes, there was evidence of erosion gullies and wind-blown dust from the bare slopes.

*Erosion gullies – OB dump- KCM Nchanga      Un - vegetated dump – Kansanshi Mine*

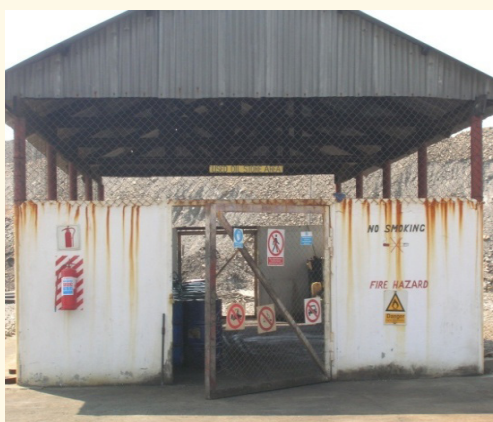
*Oil storage facility well ventilated, restricted with adequate Safety and warning signs – MCM Mufulira*

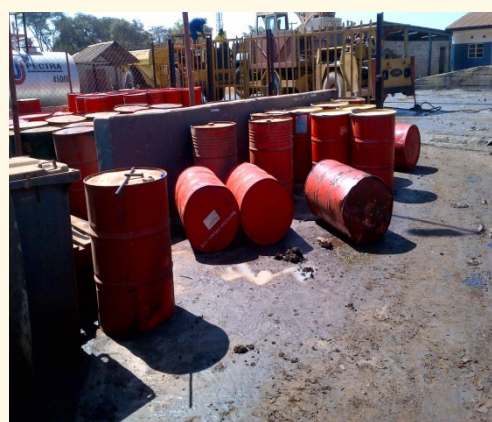
It was however observed that Konkola Copper Mine – Nchanga SBU, Chibuluma South Copper Mine, Ndola Lime Company Ltd, Maamba Collieries Plc and Chambishi Copper Smelter oil storage facilities had not restricted access to the facilities.

*Chibuluma Mine - no restricted access.*

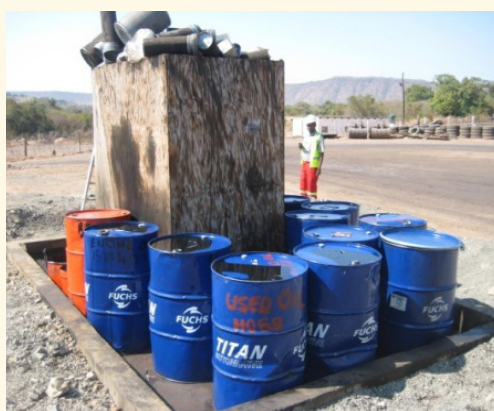
*Unrestricted access-Maamba Collieries Plc*

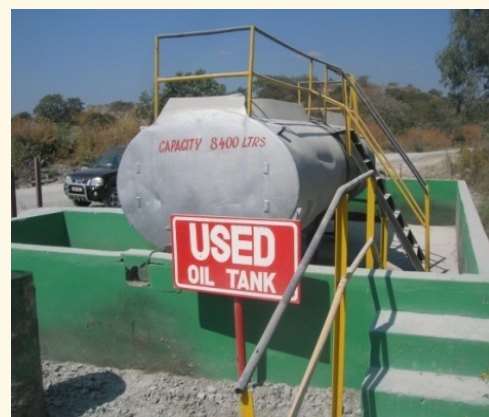
*Unrestricted access – Ndola Lime*

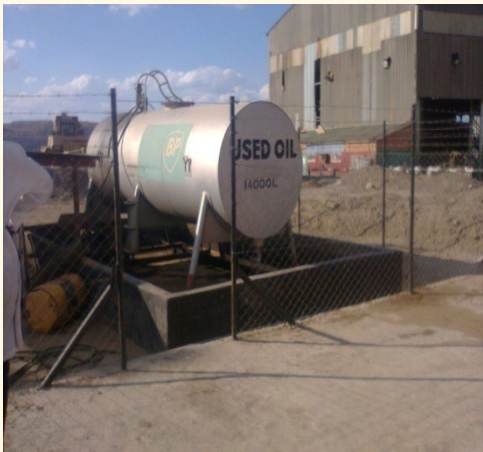
A review of compliance monitoring reports and a physical inspection revealed that Chambishi Copper Smelter, Maamba Collieries Plc. and Konkola Nchanga had no warning signs.

*KCM Nchanga - inadequate hazardous signage*

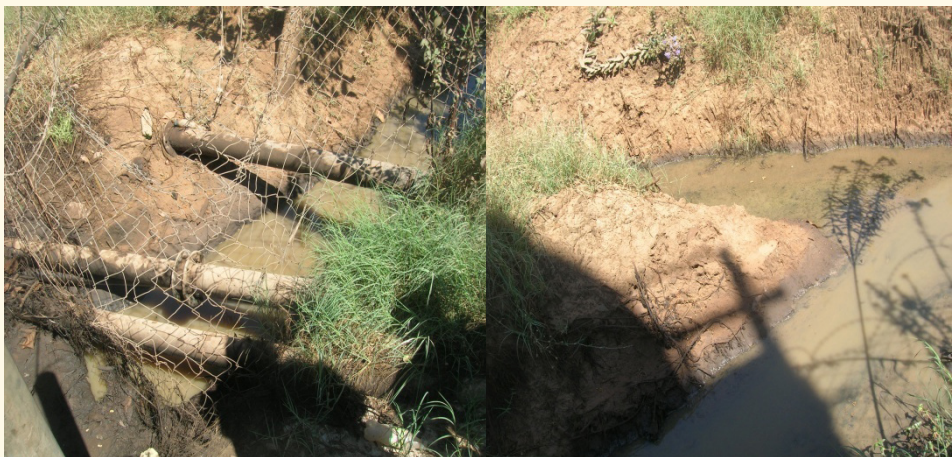
It was also observed that storage facilities for Chambishi Copper Smelter, Ndola Lime Co. Ltd, Chambishi Metals Plc., Luanshya Copper Mine, Maamba Collieries Ltd, Kansanshi, Chibuluma, Mopani Nkana Mine, Mopani Copper Mine - Mufulira and KCM - Nkana had oil spillages in or around their oil storage facilities. Chibuluma Mine storage facility had a wash bay nearby and the silt from the wash bay was mixing with the oil spills around the storage facility and ended up in unlined drainages and the environment outside the mining area. See pictures below.

*Oil- contaminated water from the wash bay released to the environment-Chibuluma Mine Plc*

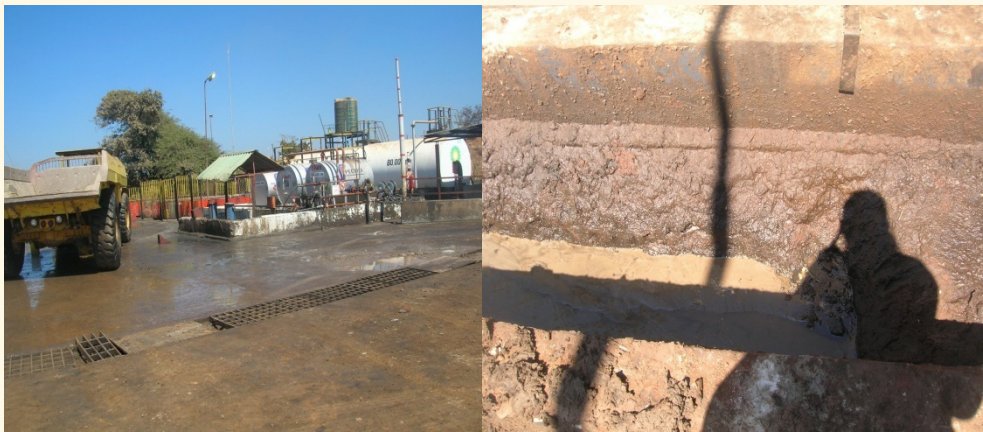
*Spilled oil comingling with water from the Mine wash bay and eventually to the environment -Chibuluma Mining Plc*

*Oil Contaminated silts in the drainage from wash bay -Chibuluma Mining Plc*

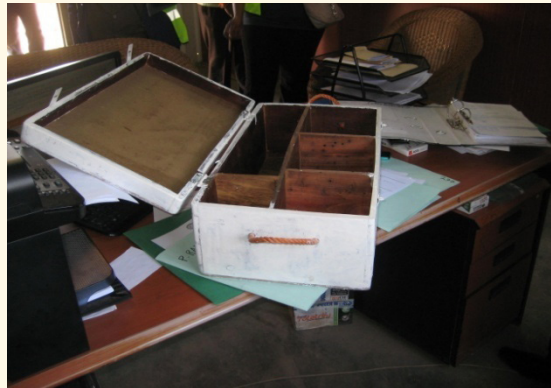
All the mining facilities visited with the exception of Luanshya Copper Mine Plc, had fire fighting equipment. It was also observed that KCM- Nchanga, Lumwana Mining Co, Chambishi Copper Smelter and Chibuluma Mine had no first aid kits on site contrary to the provisions of regulations. It was further observed that Maamba Collieries Plc. had an empty first aid box. See picture below.

*Empty first aid kit-Maamba Collieries Plc*
