Performance Audit Report of the Auditor  
General on the Sustainable Management of  
Water Resources in Zambia  
**2019 - 2022**

DECEMBER 2022

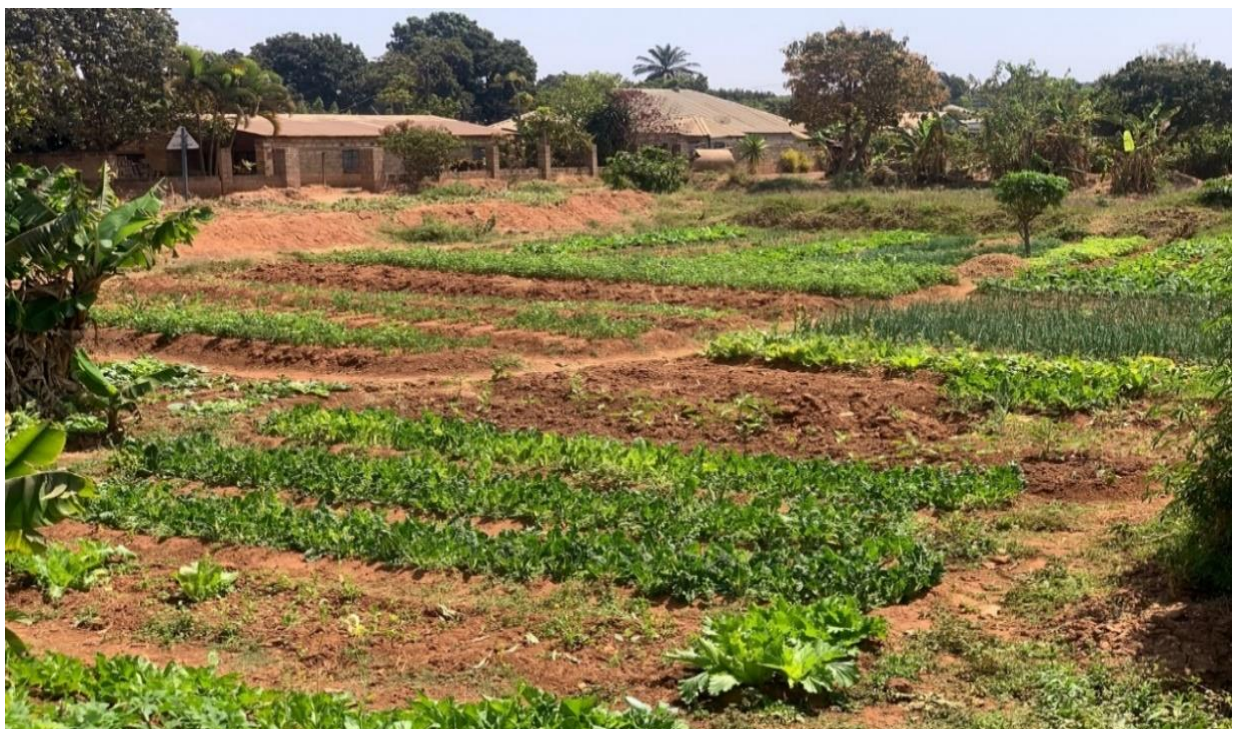
**Figure 6.1: Farming on the Kafubu River**

It was observed during the field visit of Kafubu River in Ndola that there were agricultural activities along the river banks as shown in the figure 6.1 below:

The continued agricultural activities in some dry sections of the river may result in the presence of chemicals in water which in turn may impact the quality of water in the aquatic system. This ultimately affects the provision essential benefits such as clean drinking water, recreation, transport, food, and aesthetics.

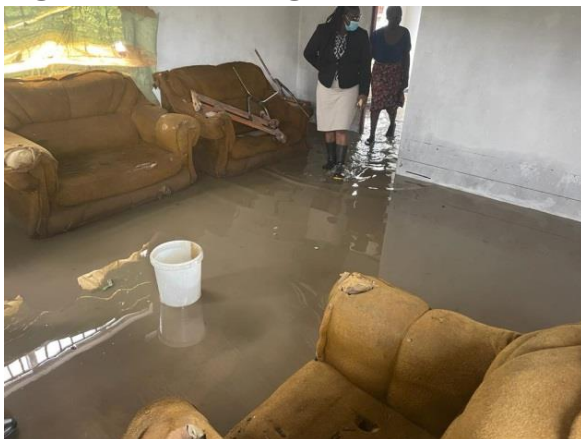
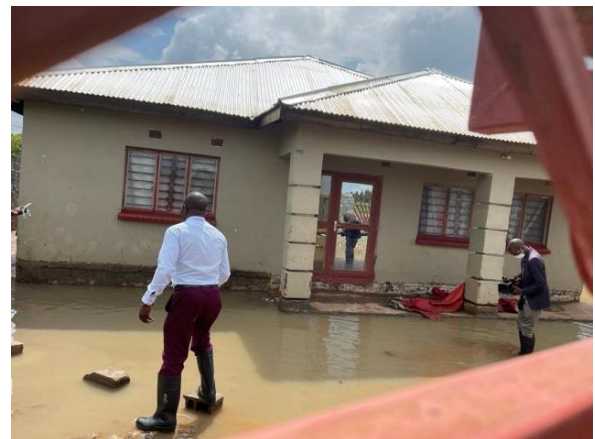
**Figure 6.2: Flooding in a House Built on the Kafubu River Bank**

- e. The banks of the Kafubu River in Ndola had construction activities along the banks with many complete and occupied houses either on the river banks or inside the dry surface land of the river, a situation which posed a great danger on the sustainability of the river and safety of occupants. In this regard, Ndola City Council reported that some occupied houses around the Kafubu River were flooded during the 2021/2022 rain season and as a result were inhabitable as shown in figures 6.2 and 6.3(a) and (b) below:

During interviews with Ndola City Council, it was reported that the LA did not allocate plots within the Kafubu River system and that most occupants acquired the land through political connections. It was further noted that the LA failed to enforce laws to prevent land illegalities or demolish structures built within the river system.

Consequently, due to failure by the LA to regulate and stop construction activities in Kafubu River buffer zone, the sustainability of the river system was compromised thereby affecting the provision of important ecosystem services such as drinking water, irrigation, flood control, recreation, and habitat for fish and wildlife. This in turn has resulted in a number of adverse effects on river water quality which include erosion, ecological damage, sedimentation and urban storm water runoff.

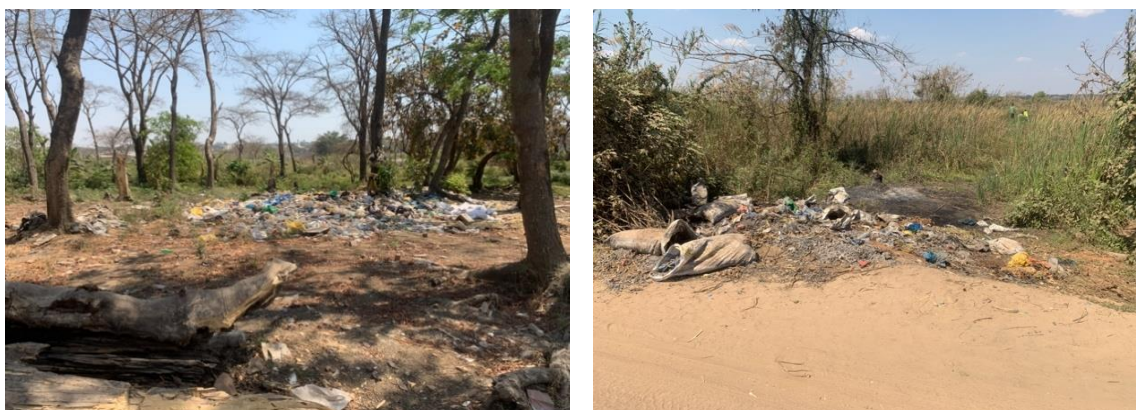
**Figure 6.4: Dumping of Waste along the Kafubu River Banks**

During the field visit, it was observed that there was dumping of waste in the river and along the banks of the river. For example, at Kafubu River, there was a heap of comingled waste dumped along the river bank with some waste spilling into the river as shown in figure 6.4 below:

Interviews with Ndola City Council revealed that some Ndola residents were in a habit of avoiding paying for garbage collection and resorted to illegally dumping their waste along the Kafubu river bank, which in turn may pollute the water resource.

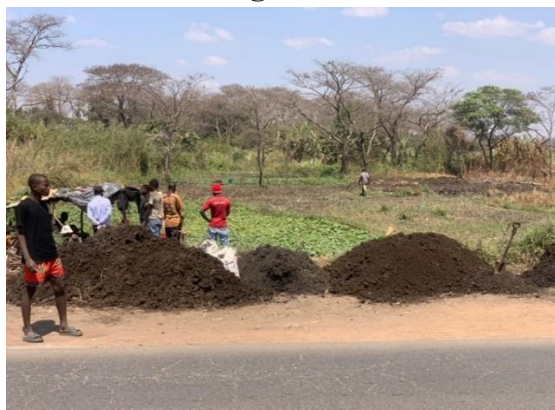
**Figure 6.5 a: Black Soil Mining along Kafubu**

Physical inspections along Kafubu River bank in Ndola revealed the presence of sand and black soil mining as can be seen in figure 6.5 (a) and 6.5 (b) below:

Ndola City Council indicated that concerns were increasing regarding the impact of sand and soil mining (aggregate mining) to the human health and ecosystems that depended on the river. This led to loss of habitats, physical changes to river system, water quality changes affecting physical or chemical conditions and hydraulic changes affecting movement of fish and habitat availability. Consequently, unsustainable sand and soil mining may result in riverbank collapse, deepening of river beds, sinking deltas and erosion as well as biodiversity loss thereby degrading the environment and destroying water sources.

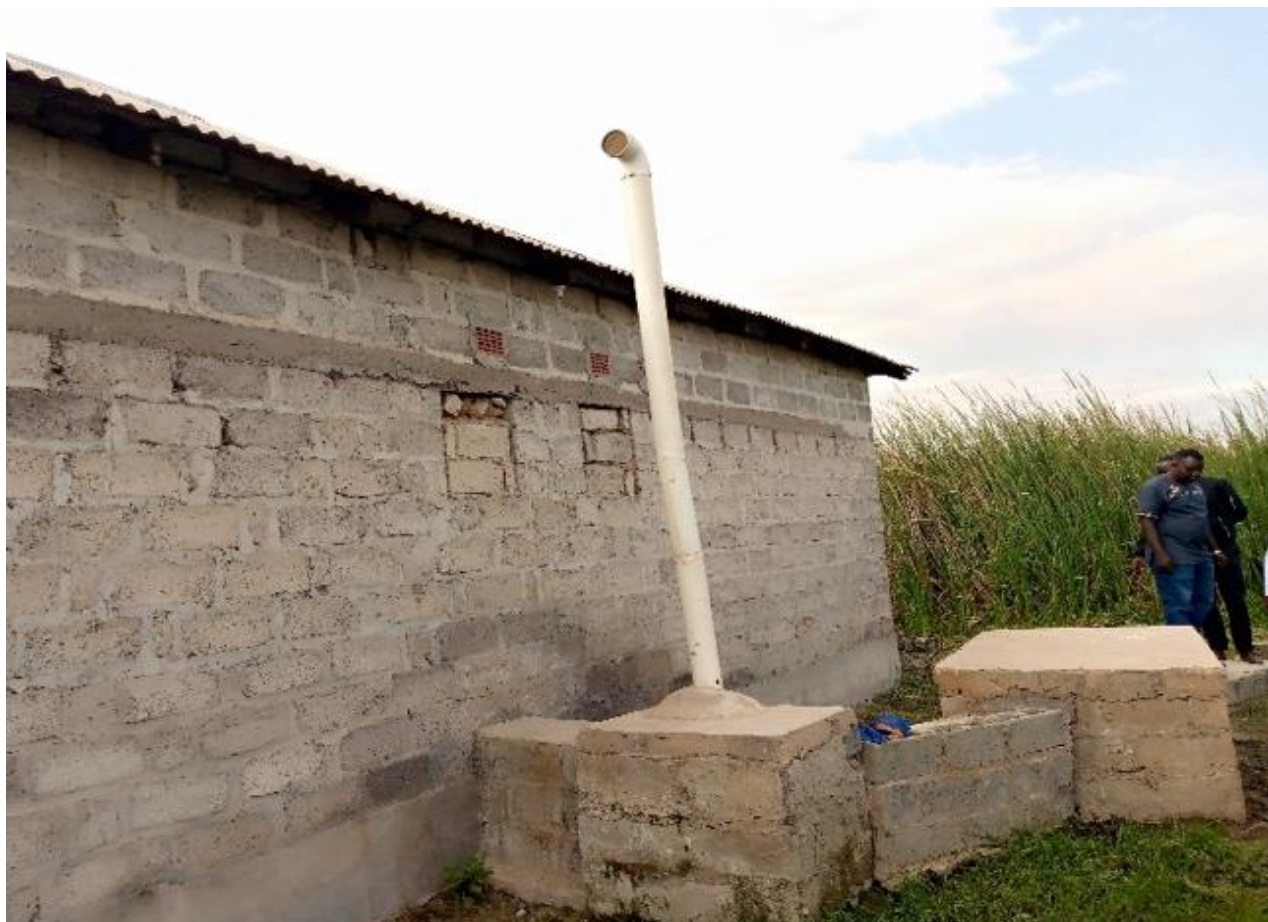
**Figure 6.6(a): Septic Tank along the Riverbank - Source: Performance Audit –2022**

A field visit at Kafubu River revealed that residents constructed septic tanks in the water resource buffer zone as shown in figure 6.6 (a) below:

As can be seen from the pictures above, Ndola City Council did not halt the construction activities in their initial stages. Consequently, this has raised serious sanitation concerns posing health risks resulting from seepage of effluent into the river. This may negatively impact water quality due to discharges of untreated wastewater which may result into waterborne diseases.

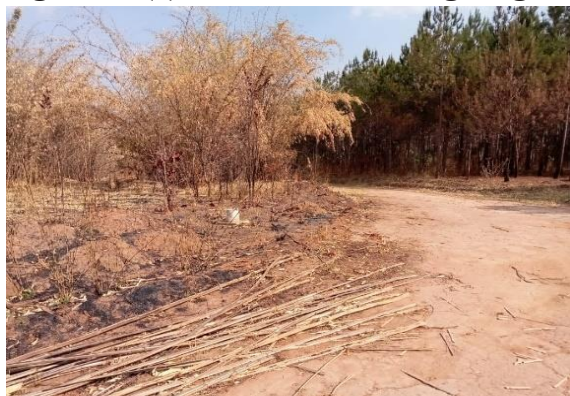
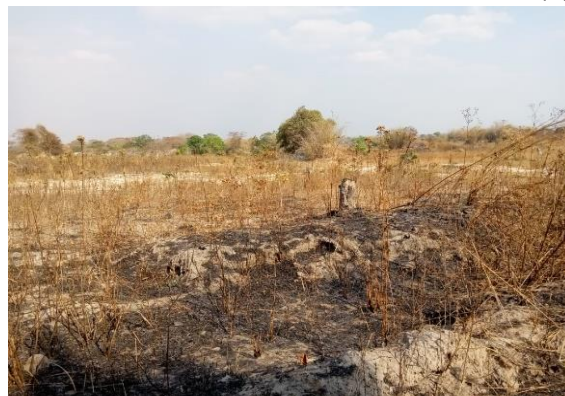
**Figure 6.7(a): Beacons Indicating Illegal Land Allocation in Masansa Forest Reserve 6.7(b)**

Interviews with officials from the Forestry department also revealed that the main cause of illegal activities in protected areas was lack of collaboration with LAs as land was allocated to citizens despite the forests being gazetted. There is a risk that the water resources may be disturbed thereby affecting the biodiversity and water eco system, which may cause drought as rivers may dry.

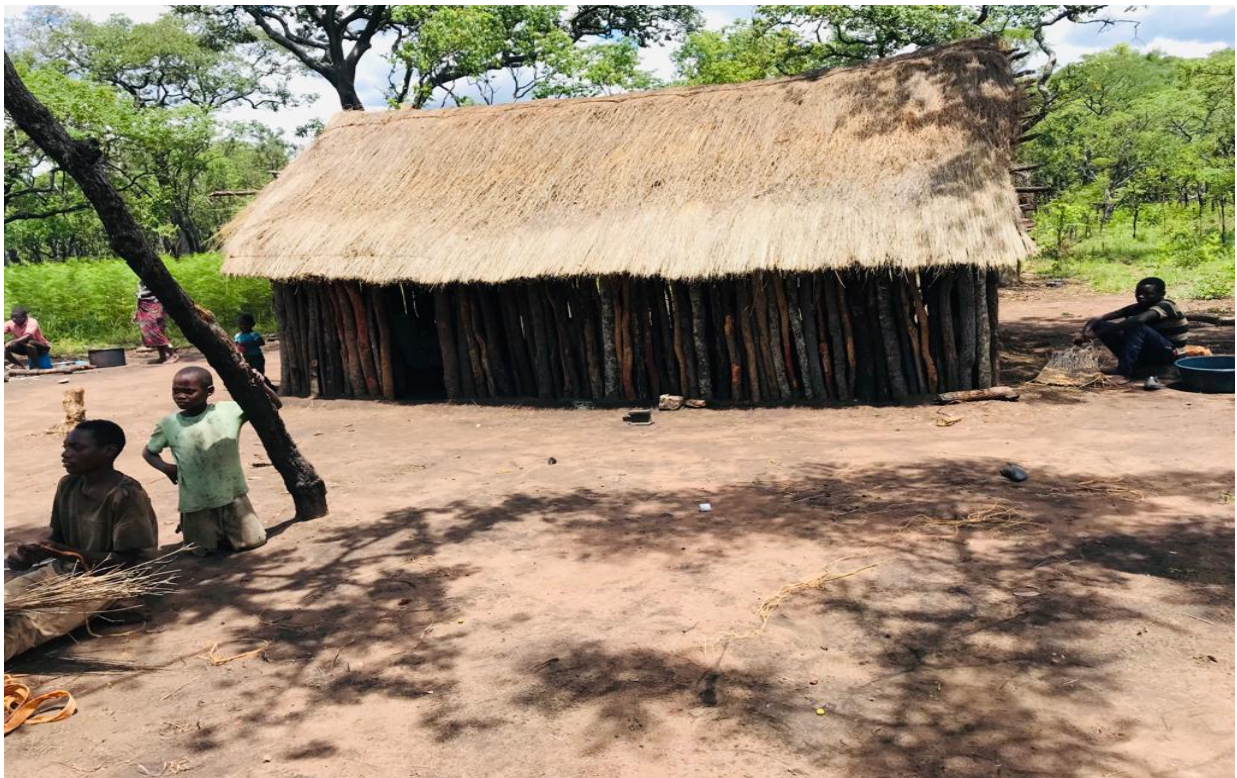
**Figure 6.9: Makeshift Structure in Mulembo Forest**

The audit established that there were illegal settlers within forest reserves who were not issued with eviction notices. For example, a review of the Central Province Monitoring Report for 2022 revealed that the Mulembo Local Forest, FR No. 210 which is 19,395 hectares in extent and home to six (6) river sources had an influx of illegal settlers who were allocated land by the traditional leadership. It was further revealed that settlers cleared trees by setting fires on the tree base which were later used to construct makeshift structures. See figure 6.9, 6.10 and 6.11 below:

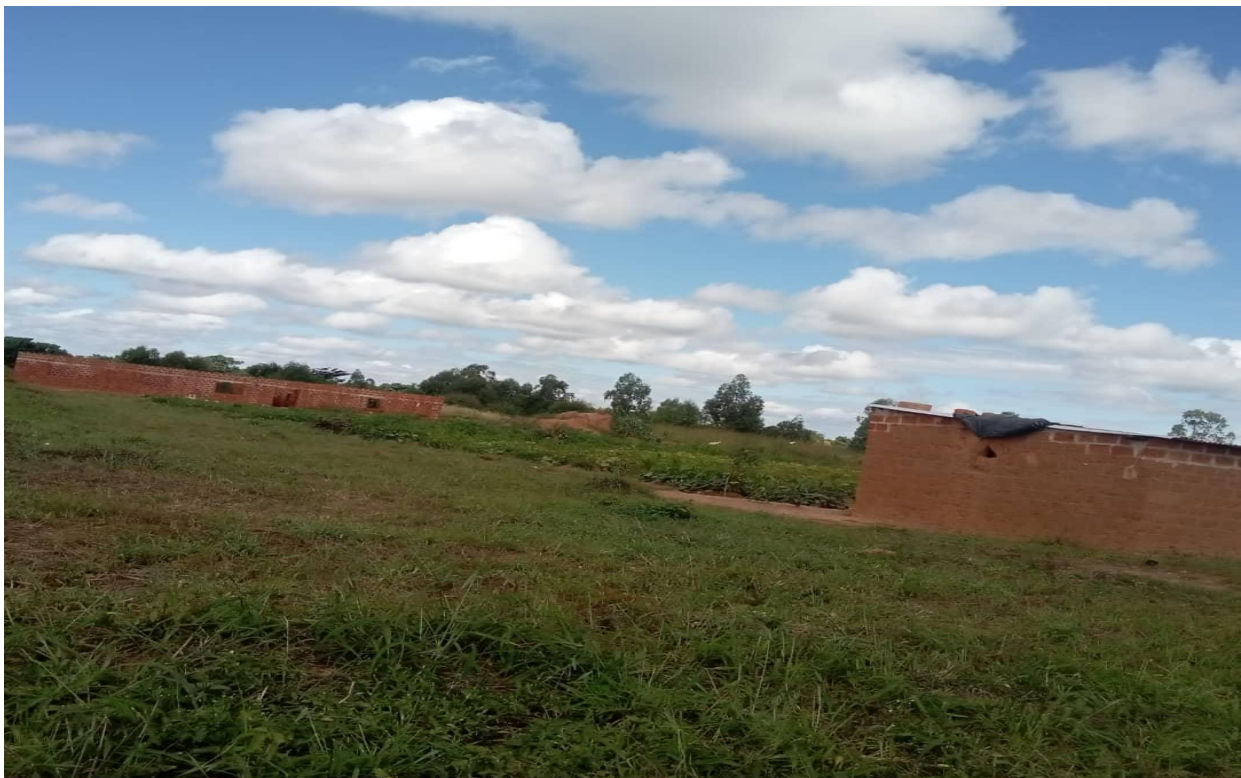
**Figure 6.12: Illegal Settlements and Agriculture Activities - Kabwe Forest Reserve Area**

Further, physical inspections of the Mansansa National Forest in Luanshya, source of the Kasongo river, which feeds into the Kafue river which has a stretch of 1576 kilometres and traverses through the North-western, Copperbelt, Central, Lusaka and Southern provinces revealed that there were illegal activities such as construction of permanent and semi-permanent structures, cultivation, harvesting of forest products and gravel mining. See figure 6.12 below:

Lack of Forest Management Committees contributed to the illegal activities in the forest reserves. This may lead to compromised water quality and depletion of water resources.

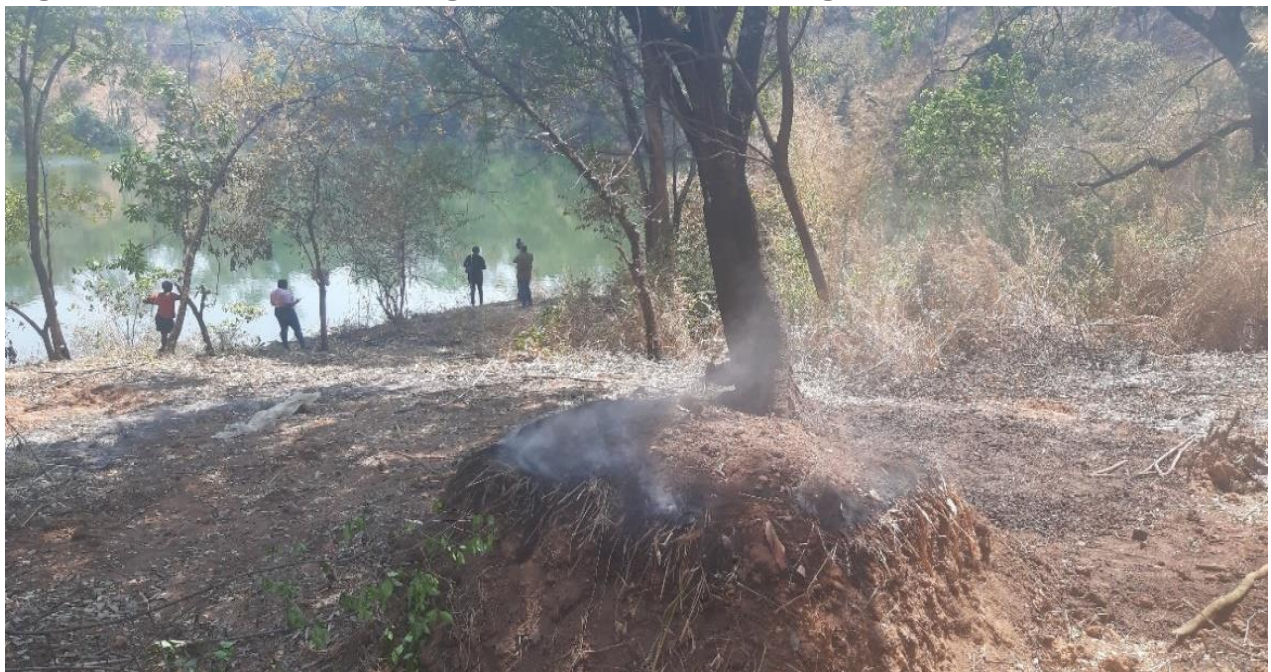
**Figure 6.15: Charcoal Burning Activities - Lake Chilengwa in Masaiti District**

Interviews revealed that the NHCC on the Copperbelt was unable to carry out monitoring activities of the water resources because the office had one pool vehicle which was being used by the regional manager for the North-Western Region who was based in Solwezi. In addition, the Eastern region had one (1) motor vehicle, purchased in 1992, which had mechanical faults. As a result, most heritage sites (water resources) were encroached by people undertaking various activities such as agriculture and charcoal production. For example, some members of the community surrounding Lake Chilengwa in Masaiti district cut down trees for charcoal production. This scenario if left unchecked may result in depletion of water resources and recharge zones. See Figure 6.15 below.
